# Careless Creek Monitoring Project Final Report

Victoria Bunn and Adam Sigler  
MSU Extension Water Quality

Lower Musselshell Conservation District

January 25<sup>th</sup>, 2013

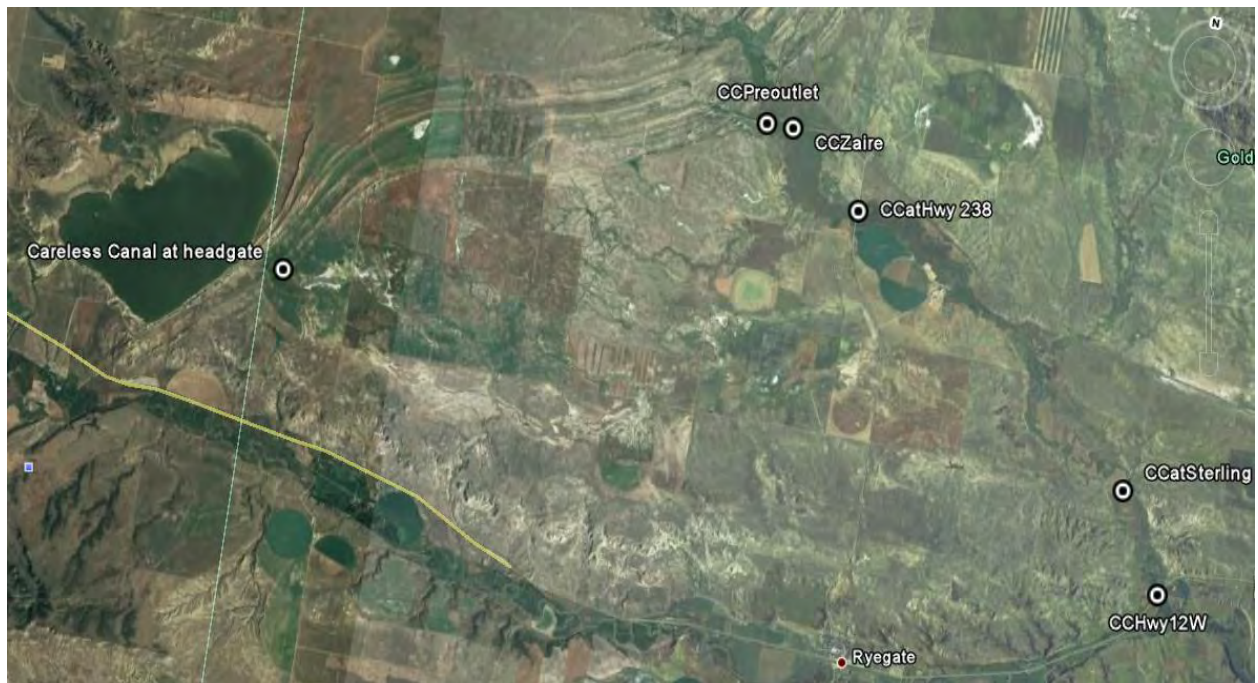
Figure 1. Careless Creek project sampling sites, 2009.

Per the approved SAP, six sites were chosen at the onset of monitoring efforts for sampling within the Careless Creek watershed. The selected sites were chosen because of a sampling history pre/post TMDL development, or because they were identified during a scoping trip as locations that would be helpful in defining water quality conditions within Careless Creek (Figure 1). Two sample sites were moved after the 2009 season, prior to initiating data collection in 2010. The PreOutlet site was moved upstream approximately 0.25 miles to avoid backwater from the canal confluence interfering with the stage recorder, and the Canal site was moved downstream a little over 5 miles to just above the spillway into Careless Creek (Figure 2). The new Canal site provided a better stage versus discharge relationship and also significantly reduced the travel time associated with sampling. These sites remained the same for 2011. In 2012, the number of sites was reduced from six to four by eliminating the Sterling and Hwy 238 sites. This reduction was the outcome of a decision made by MWC, MSUEWQ and MDEQ to make the most efficient use of modest remaining funds and diminished volunteer commitment. A summary of the sites used throughout the study period, including station IDs and coordinates, can be found in Table 1.

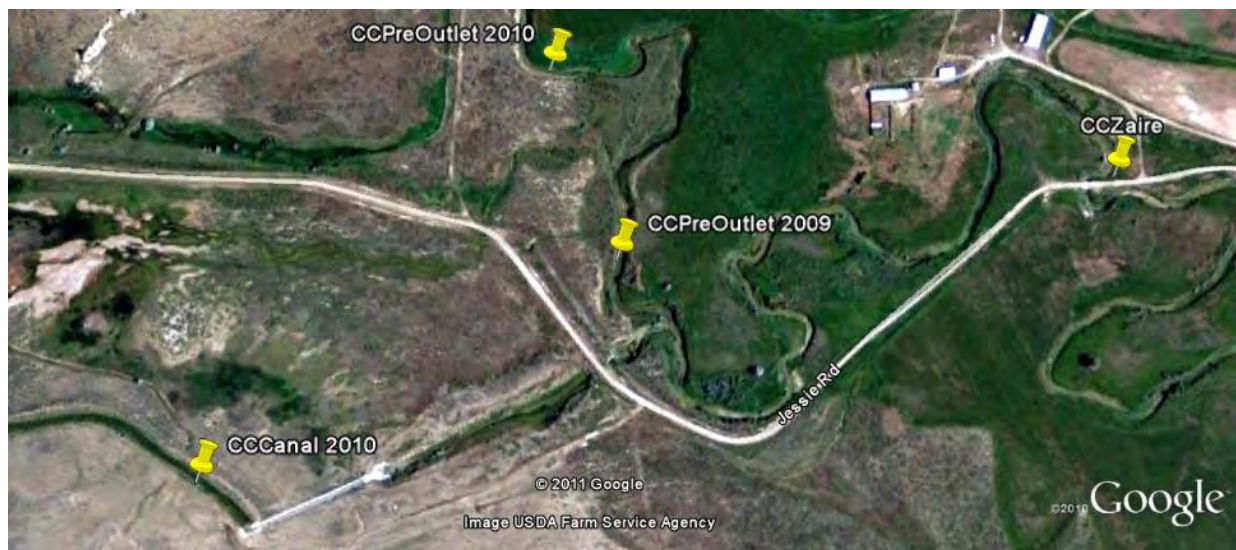
Figure 2. Careless Creek project sampling sites relocated in 2010 (Canal and PreOutlet).

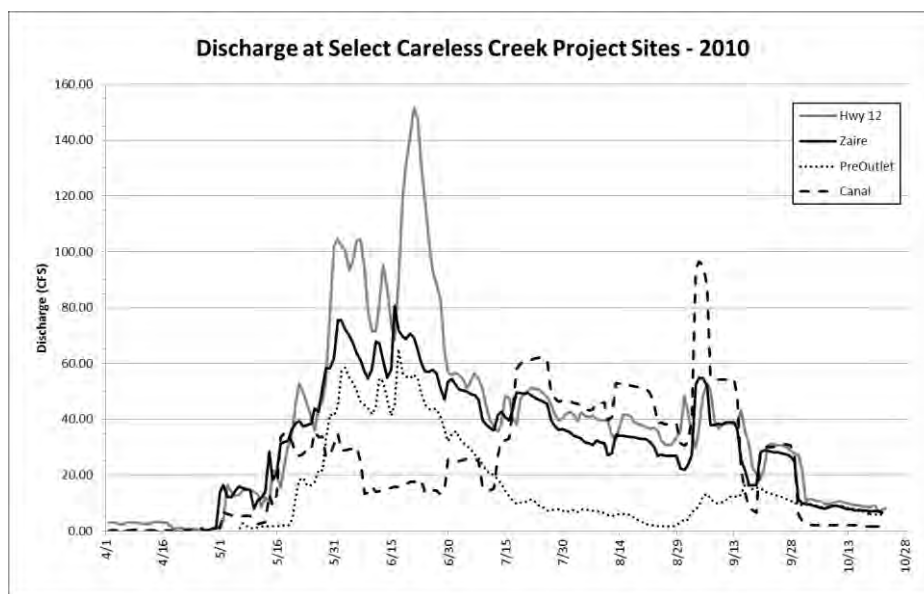
Movement of the Canal and PreOutlet sites in 2010 allowed for data collection that tells the story of how the canal influences discharge in Careless Creek (Figure 3). Discharge from the canal into Careless Creek ended around October 1<sup>st</sup> in 2010. Zaire is the sample site just downstream from where the canal enters Careless Creek, and is the site where flow alterations from the canal are most pronounced. During non-irrigation months, discharge at Zaire is controlled by discharge coming down Careless Creek at PreOutlet. In 2010, the discharge at Zaire began to rise above winter baseflow at the beginning of May as a result of increasing flow in the canal. Around the end of May, discharge from Careless Creek at PreOutlet surpassed discharge entering from the canal and the Zaire hydrograph was dominated by the flow from PreOutlet. Around July 13<sup>th</sup>, flow at PreOutlet dropped below the amount of flow from the Canal site. For the rest of the irrigation season, flow from the canal was the dominant source of flow at Zaire. While the influence of flow from the canal in Careless Creek can be seen throughout the irrigation season, the influence is most pronounced when runoff tapers off in mid-July.

Figure 3. 2010 hydrograph from four Careless Creek project sites.

While 2009 site placement and 2011 flooding left holes in the data for the study period, TruTrack data indicates that the first objective set forth in the water quality restoration plan are being met. Discharge from Deadman’s Reservoir to Careless Creek via the canal did not exceed 100 cfs during the study period, and while discharge regularly exceed 80 cfs at the confluence of Careless Creek and the Musselshell River during the study period, these events were all associated with natural peaks in the hydrograph (late May to late July) and do not correlate with canal releases (Figure 3).

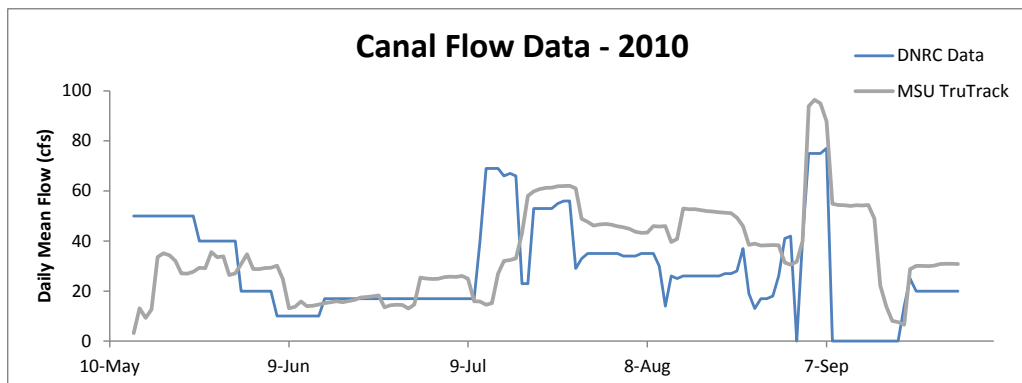
Figure 4. 2010 hydrograph for Canal site made with MSU TruTrack data and DNRC Canal release data.

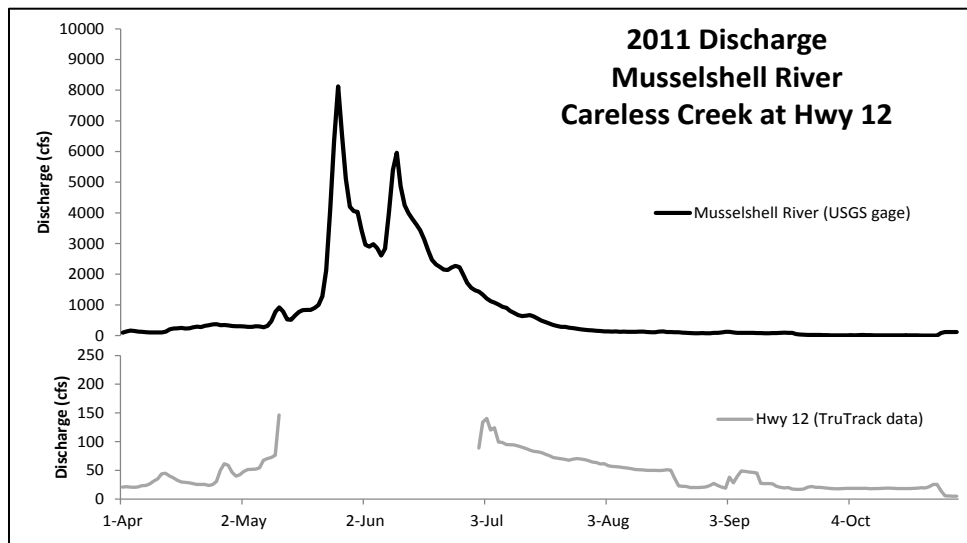
In 2011, the Musselshell watershed experienced record flooding. The high water levels washed out many of the project TruTracks, resulting in missing data during flood stage flows. Figure 5 shows discharge in both the Musselshell River and in Careless Creek at its mouth, and indicates that flow in Careless Creek roughly paralleled that of the Musselshell for the periods with data. Figure 6 includes estimated data for Careless Creek during the missing data period (dashed line). The missing Careless Creek data was estimated using Musselshell data for the same period, and the average relative percent flow in Careless Creek for the two weeks before and after the missing data period. This method indicates that peak flow in Careless Creek was approximately 1200 cfs during the 2011 flooding.

Figure 5. 2011 hydrograph from the Musselshell River and Careless Creek @ Hwy 12. Musselshell discharge peaked at 8120 cfs on May 26.

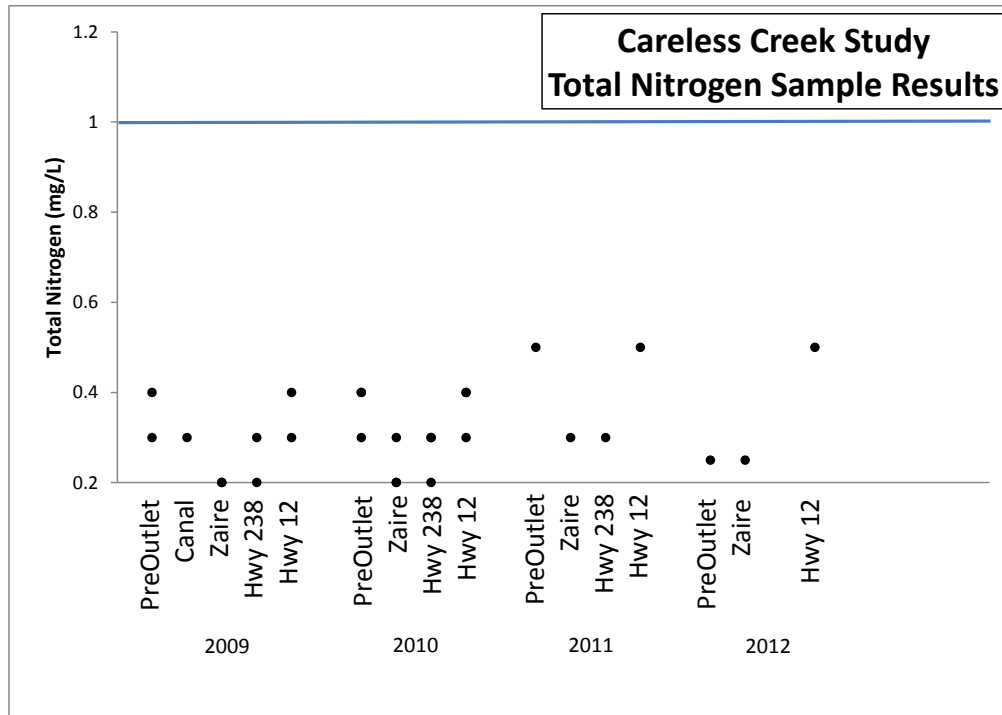
Figure 9. Total nitrogen levels for all samples taken during the study period. MDEQ Circular 12 standard for total nitrogen (1.0 mg/L) shown as a blue line.

Three forms of nitrogen [ammonia ( $\text{NH}_{3+4}$ ), nitrate + nitrite ( $\text{NO}_{2+3}$ ), and total persulfate nitrogen (TN)] and total phosphorous (TP) were analyzed during the study period. For detailed information on sample locations and timing, see Table 2. None of the samples collected during the study period produced a value for ammonia (detection limit of 0.05 mg/L). The sampling results for the remaining nutrient parameters ( $\text{NO}_{2+3}$ , TN, and TP), including the corresponding MDEQ criteria for that nutrient, are shown in Figures 8 through 10.

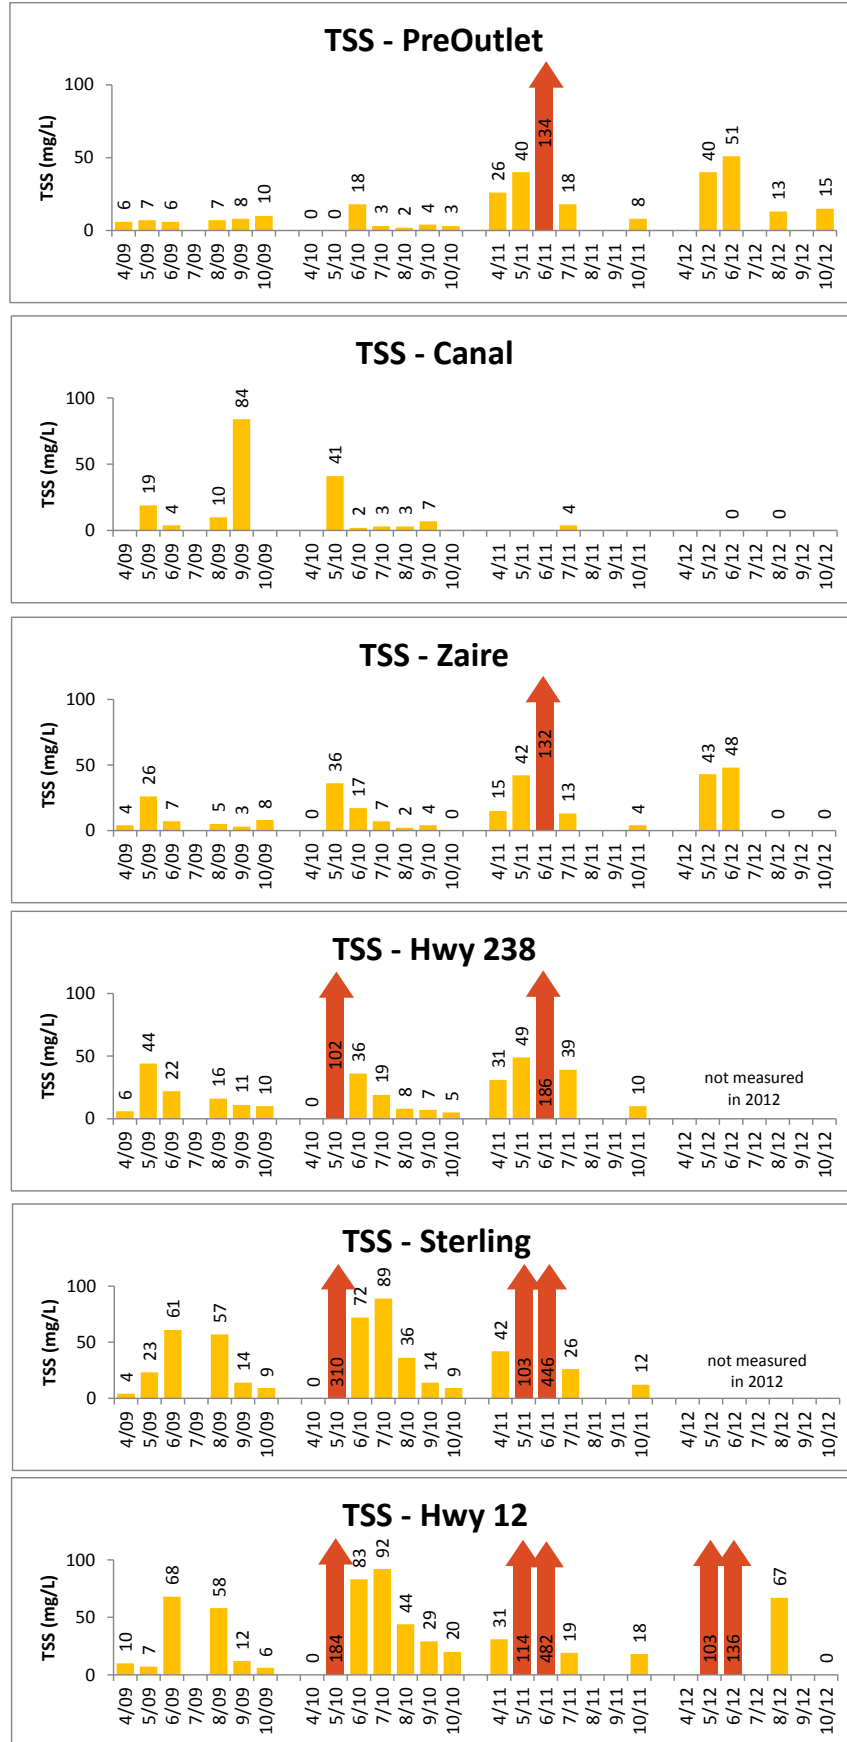
TSS concentrations (mg/L) for each study site throughout the 4-year study period are displayed in Figure 13. Flooding and erosion in the area resulted in an abnormally high measured TSS concentration for 2011 when compared to other years.

Figure 13. TSS concentrations (mg/L) for each study site, shown upstream to downstream throughout the study period (2009 – 2012). A printed value of 0 = no detect.

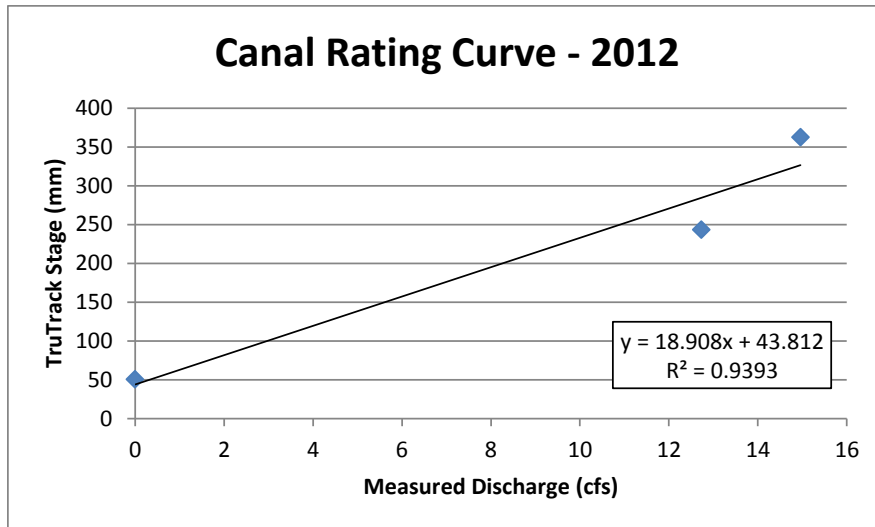
## Appendix B: 2012 Rating Curves

Trutracks were installed each year of the Careless Creek study for continuous flow monitoring during the sampling season. Trutracks were programmed to record a water level measurement every 30 minutes. Stream stage data was downloaded from all Trutracks as a part of each sampling visit, with a few exceptions in 2011, due to high water levels. Discharge measurements were made using a Marsh-McBirney model 2000 Flo-Mate portable velocity meter and top setting rod. Discharge measurements made with the flow meter were correlated with Trutrack stage height measurements to develop rating curves for calculation of estimated flow every half hour from April through November. The 2012 rating curves can be found in Appendix B. See past reports for 2009-2011 rating curves.
